Templeton-Whitney Grazing Allotments, Golden Trout Wilderness

Head Cut and Photo Point Monitoring, 2003 and 2010 (DRAFT)

By: Casey Shannon, Hydrologic Technician

Inyo National Forest, Supervisor's Office

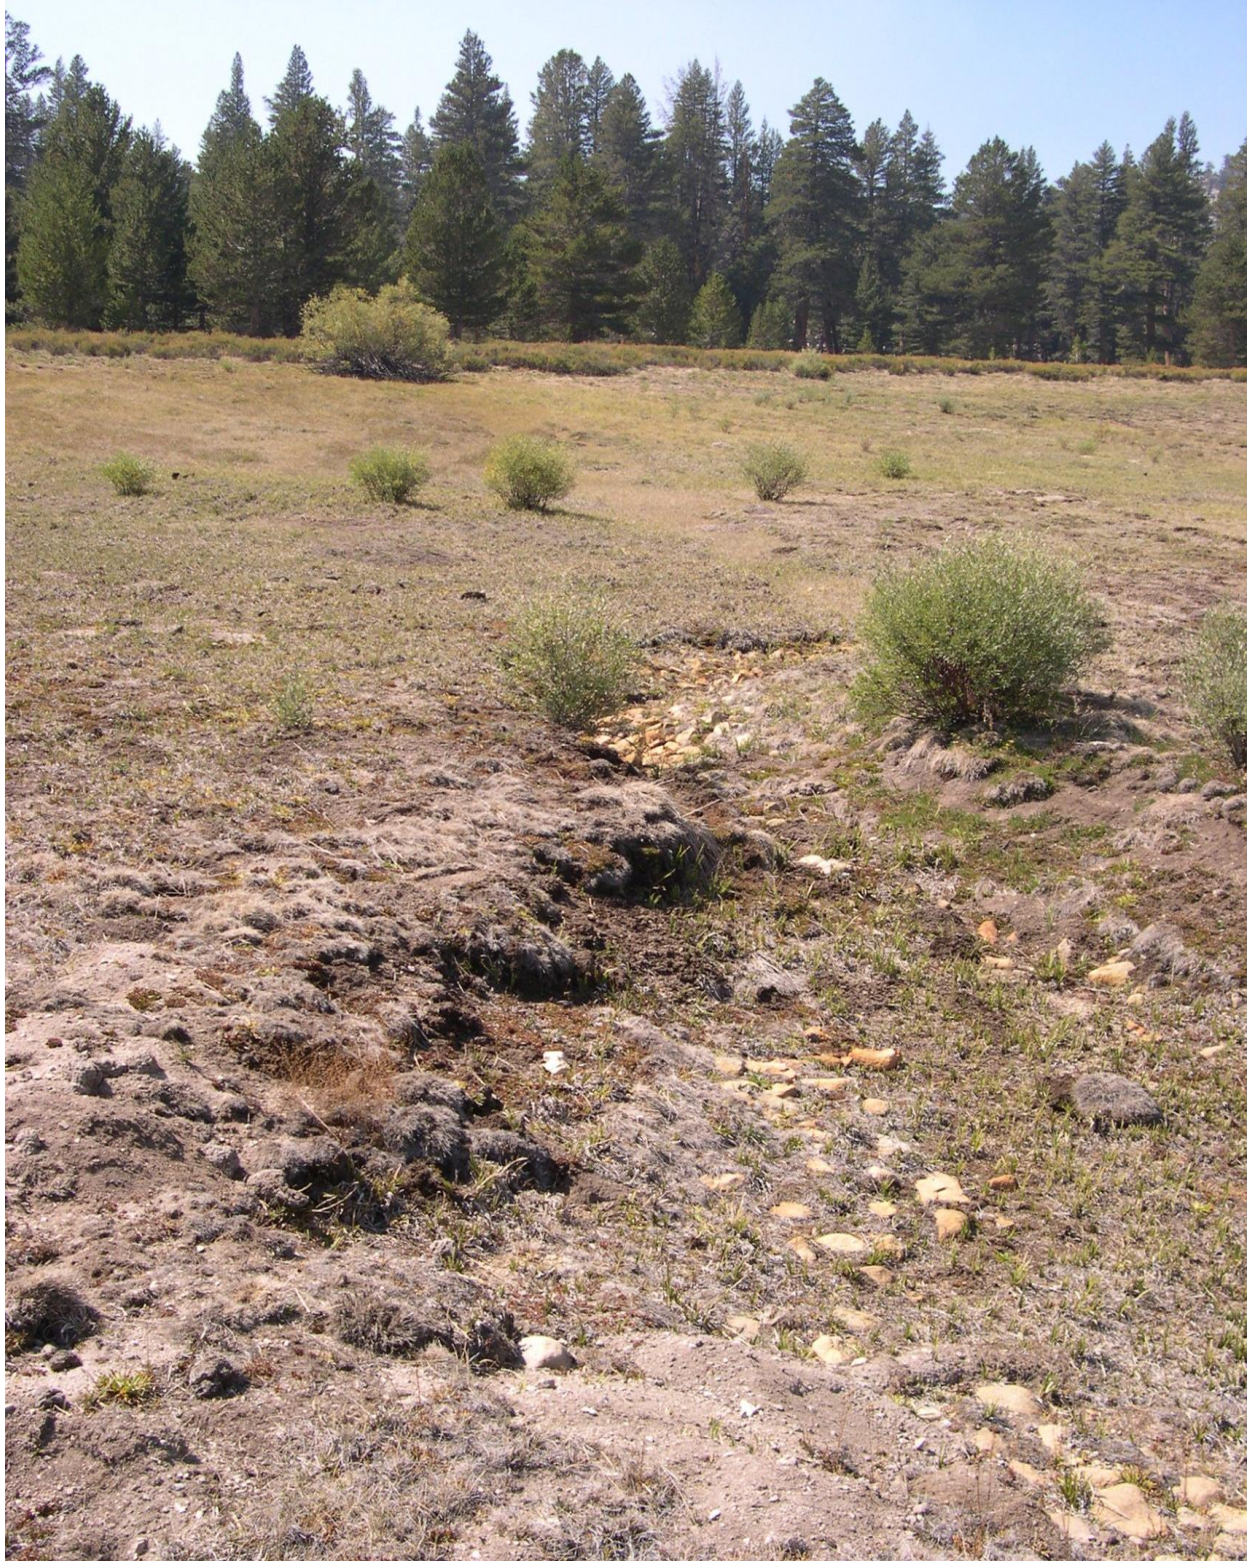
Photo: Treated head cut 387 (THC 387), Big Whitney Meadow Section 4, September 2003. A rocked chute and bank head cut treatment completed in the early 1990's. Sod is missing throughout site and bare, eroding ground is apparent. Vegetation is thin and moderately weak. Treatment slowed head cut migration. See following page for 2010 photo.

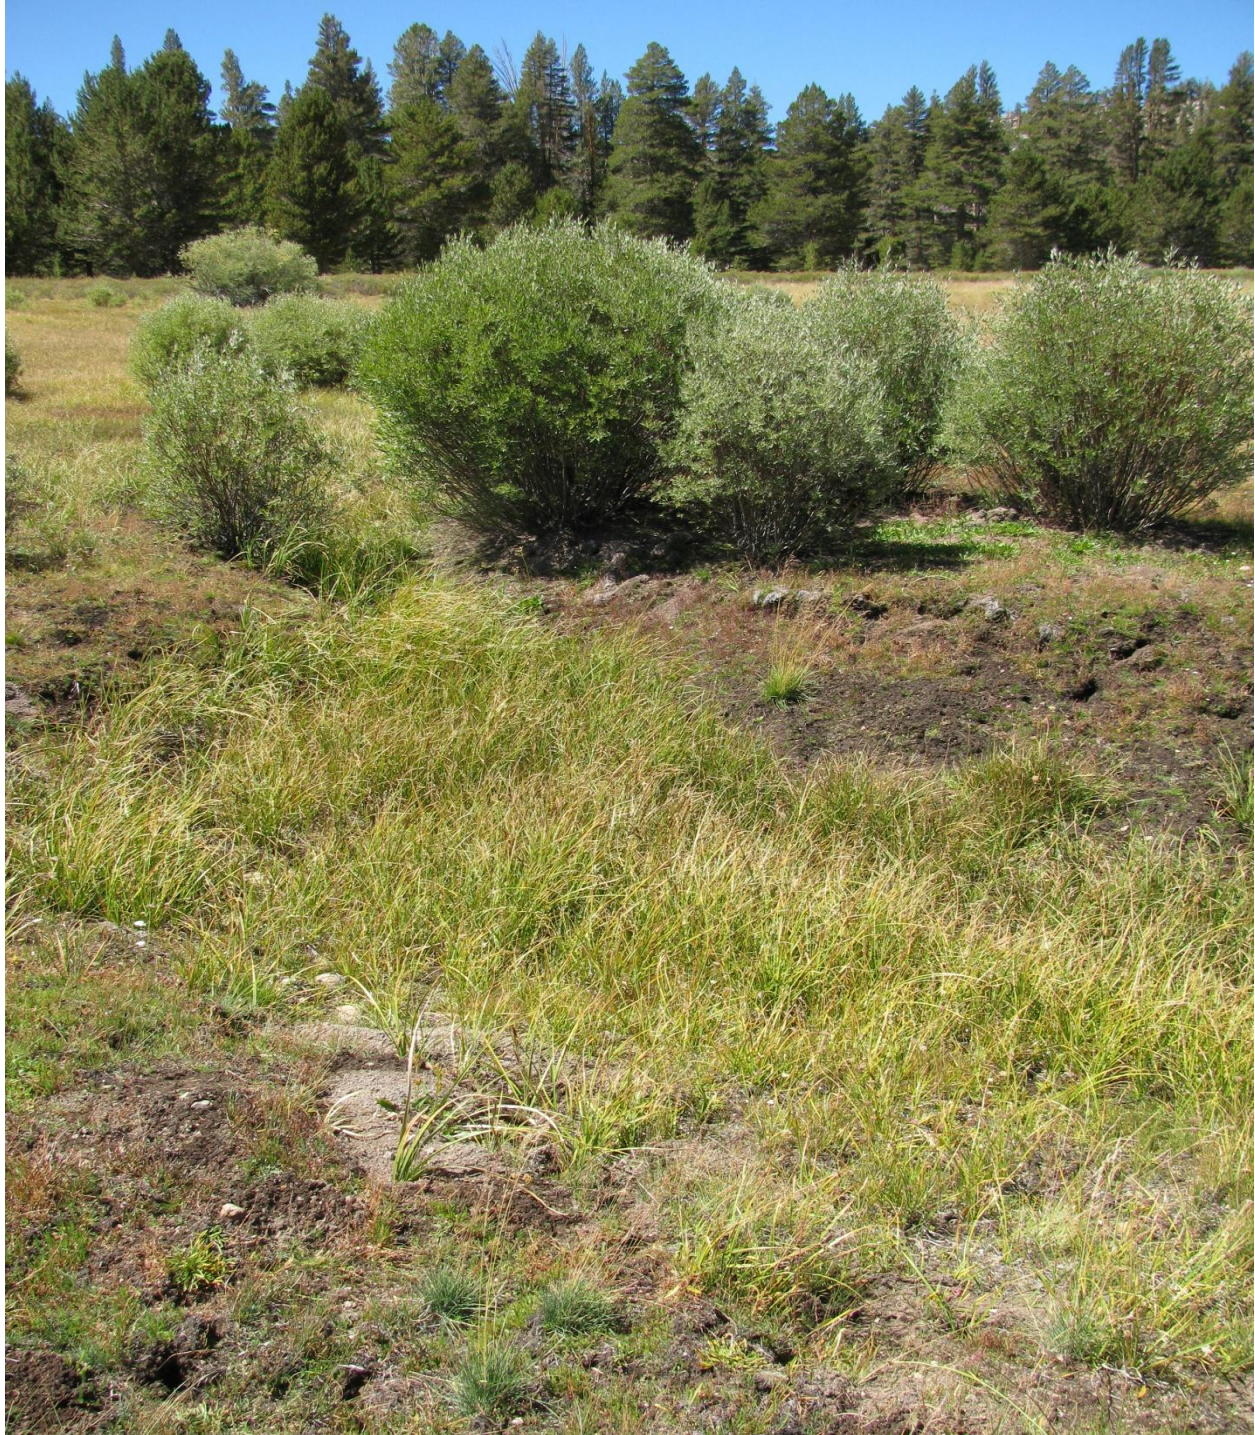
Photo: THC 387, Big Whitney Meadow Section 4, September 2010. Vegetation cover has significantly increased and gully and head cut structures have fully stabilized and filled in with sedge. Some vulnerable bare ground still exists. Willow growth has increased well also. Upward vegetative trend, recovery at site is in progress, not fully recovered.

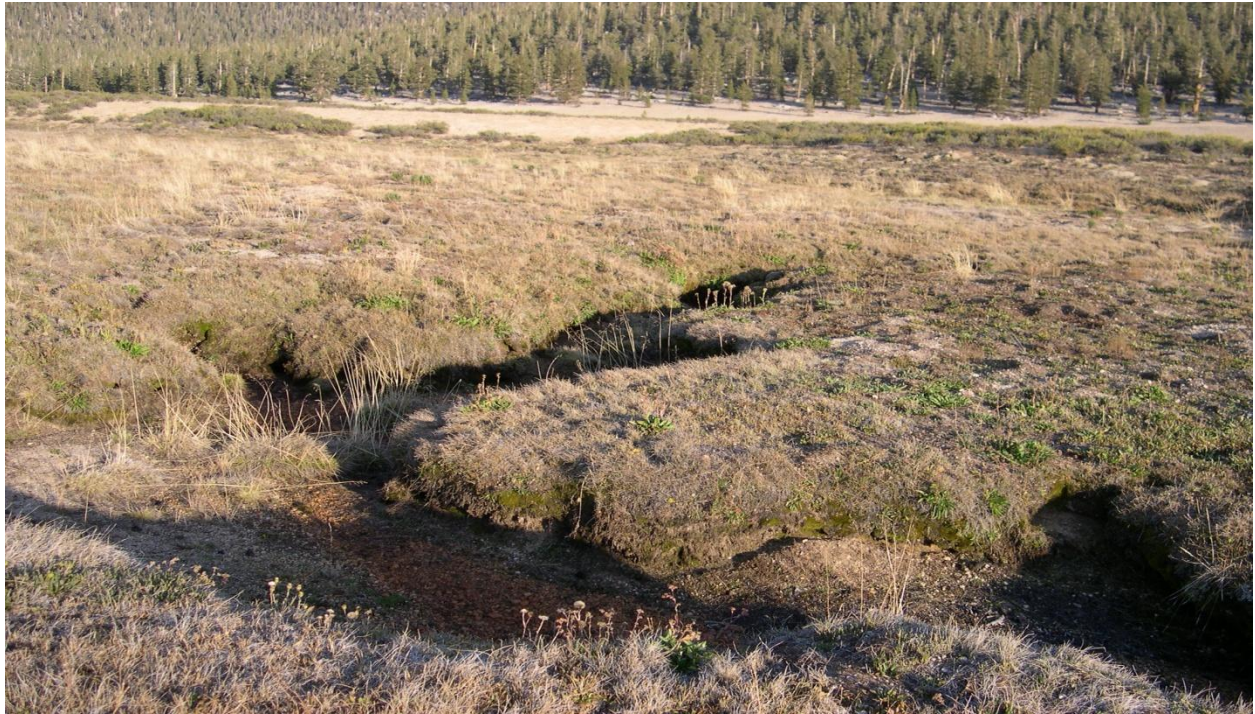
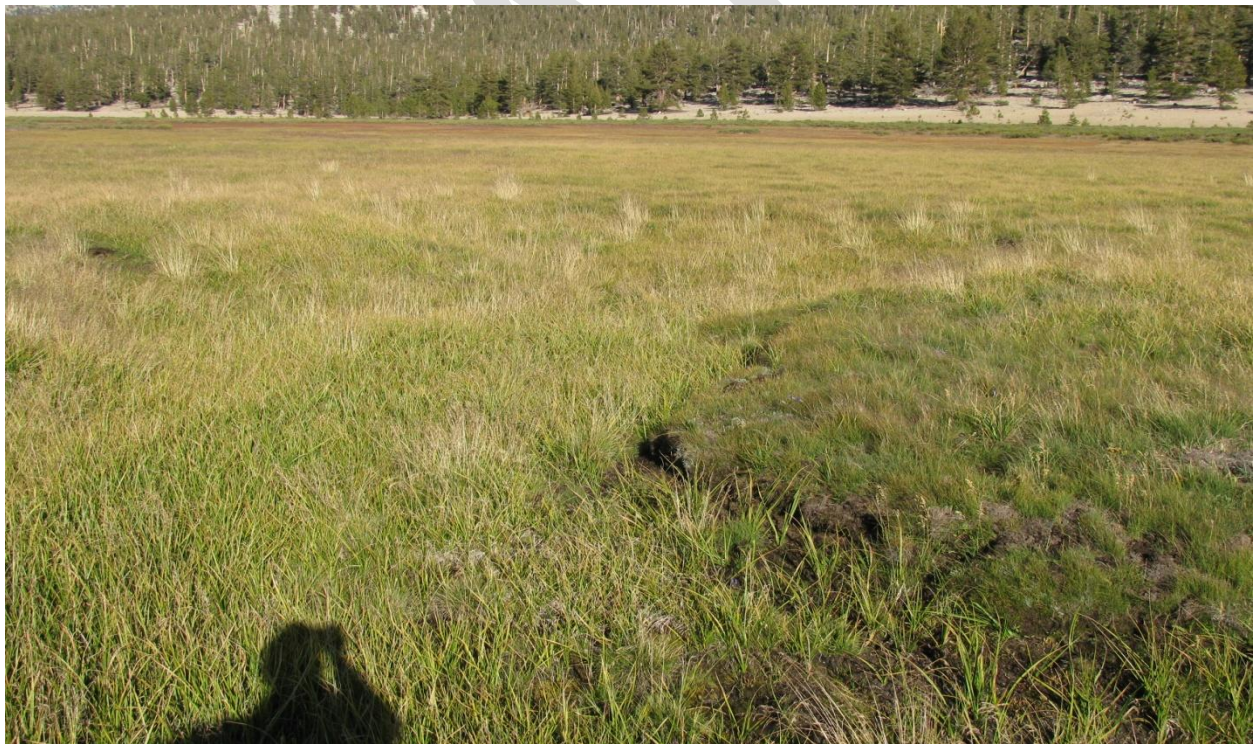
Above photo: 1999 monitoring photo point Roll 8 #24 Big Whitney Meadow Section 5, September 2003. Same photo was also taken in 1999. Unstable, incised gullies and active head cuts exist, hummocks are found on terraces. **Below photo:** 1999 PP Roll 8 # 24, photo was retaken September 2010. Gullies have significantly aggraded along with water table and very increased riparian vegetation in floodplain and terrace areas. Hummocks have diminished and vegetation on hummocks very improved with much less exposed soil. Site is wet and vulnerable, strong riparian vegetation will resist impacts and continue floodplain aggradation and water table.
